Manhole Inspection Summary

Manhole # S29E__035MH

Location Address: **220 N. Pine St**

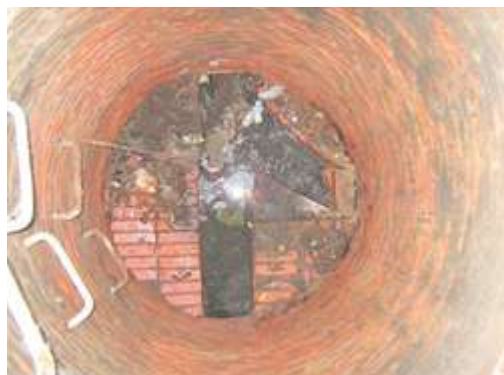
Top View

Heavy debris in channel

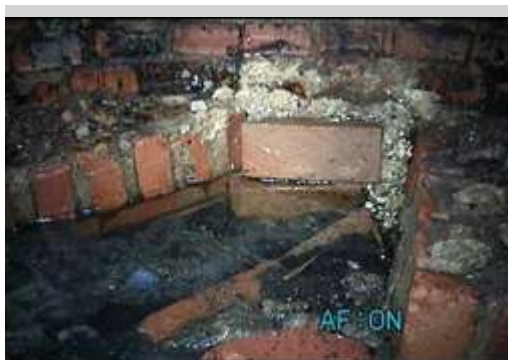
Miscellaneous

Pipe In @ 3 Oclock- Abandoned connection covered over with bricks and mortar

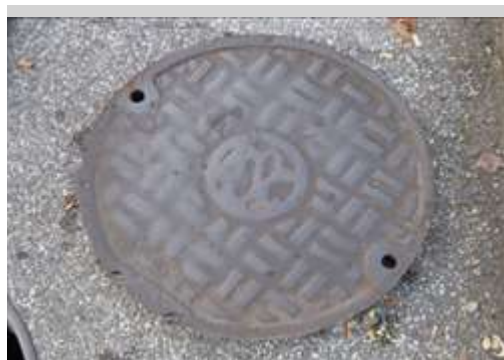
Miscellaneous

Condition: **Worn**

Worn cover

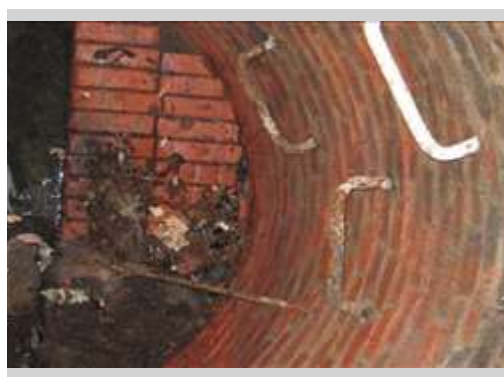
Defect 2

Count: **5** Missing: **0** ☒ **Corroded**

Corroded steps

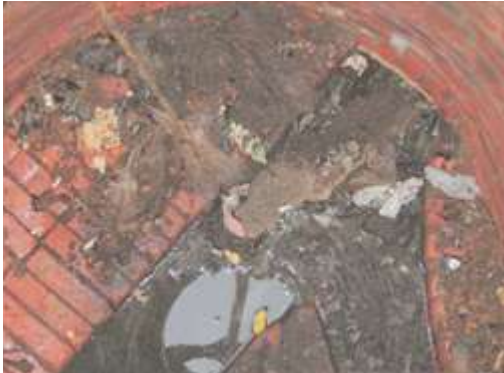
Defect 1

Condition: ☐ Sound ☐ Cracked ☐ Root Intrusion ☐ Deteriorated ☐ Leaks ☒ **Debris**

channel & bench debris

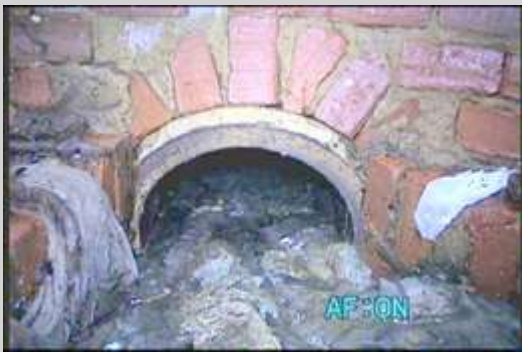
12 O'Clock Outflow

Pipe Height: **10.8** (in.) Rod and Bar (Angled)
Pipe Material: **Clay** ☐ Pipe Lined
Invert Depth: **9.44** (ft.) Flow Characteristics: **Slow**
Deposits: ☐ None ☐ Mud ☐ Sludge ☒ **Debris** ☐ Grease
Silt Depth: **0** (in.) Deposits Extent: **Heavy**
Infiltration: **None** Pipe Seal Cond: **Sound**
